Property Condition Assessment for

1234 Sample Drive

September 21, 2021

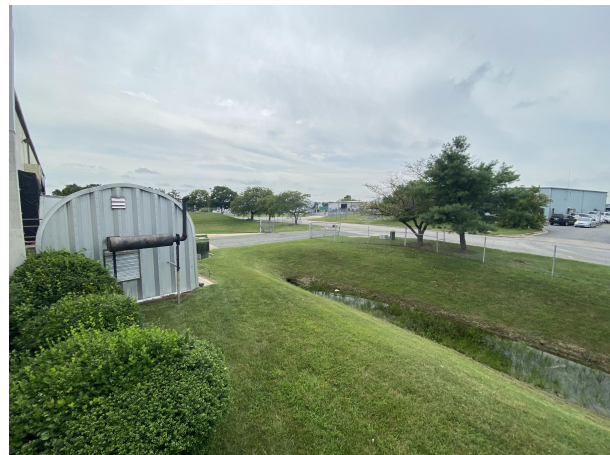
The site landscaping is in overall good condition with recently cut grass; bushes were slightly overgrown. Recommend trimming bushes and trees as part of routine site maintenance.

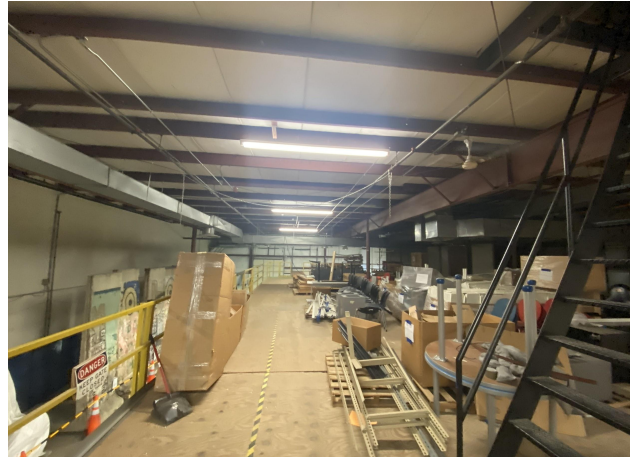
Foundation

The building's foundation is slab on grade concrete. Several stored items were present on the floor and along the CMU walls presenting a full visual evaluation; however, some cracking was observed in the concrete slab on grade. Recommend repairing/filling the cracks.

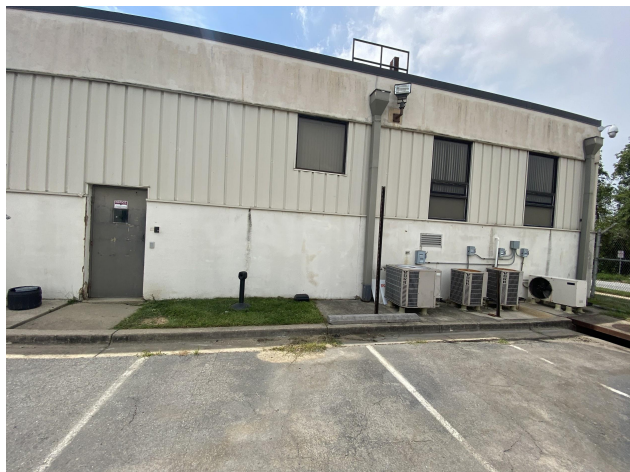
building-mounted lights are present on all sides of the building's exterior. The building's exterior cladding and windows appeared to be in overall good condition. The exterior metal doors are most likely original to the date of construction and most were difficult to open; recommend replacement.

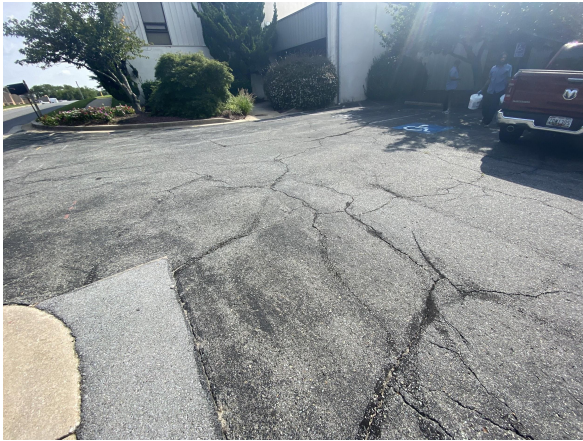
- The asphalt parking lots are in poor condition; recommend replacement.
- The Heating, Ventilation, and Air Conditioning System (HVAC)/RoofTop Units (RTUs) are nearing the end of their expected useful life; recommend evaluation by a qualified contractor to assess condition. Anticipate replacement in the short term.

Typical condition of asphalt - front lot

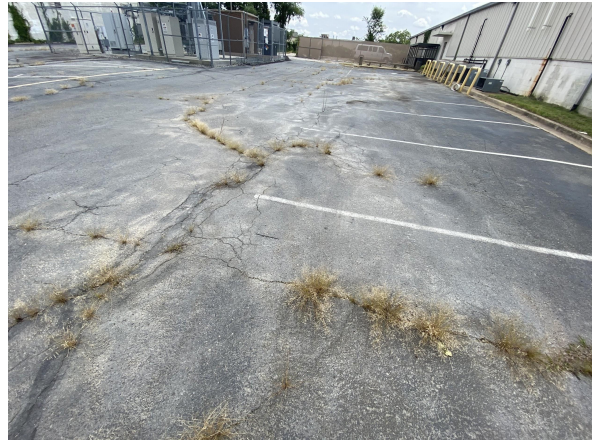
Typical condition of asphalt - rear lot

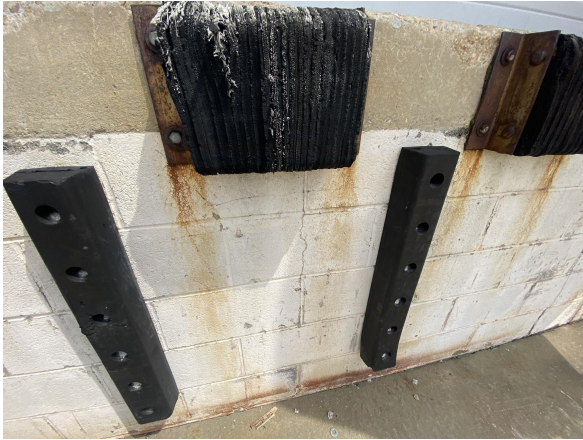
- The exterior metal doors were difficult to open; recommend replacement.
- Cracking was observed at the loading dock CMU wall; recommend properly sealing the cracks.

Cracking at loading dock

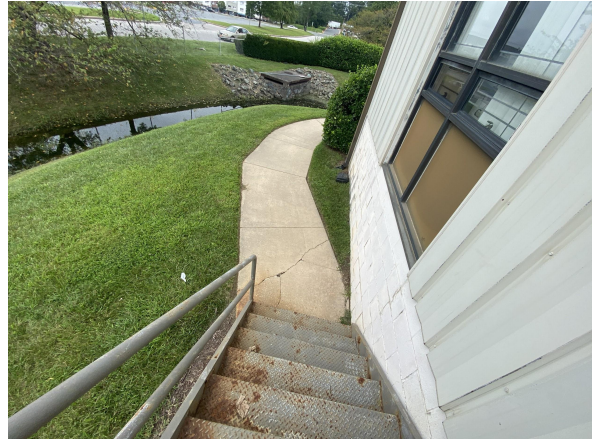
- The metal egress stairs are in poor condition; recommend replacement. The rear concrete steps at the building were cracked and should be repaired.
- The building's scuppers appear to be holding water. Recommend clearing the scuppers to allow for proper drainage.

Metal stairs at side of building

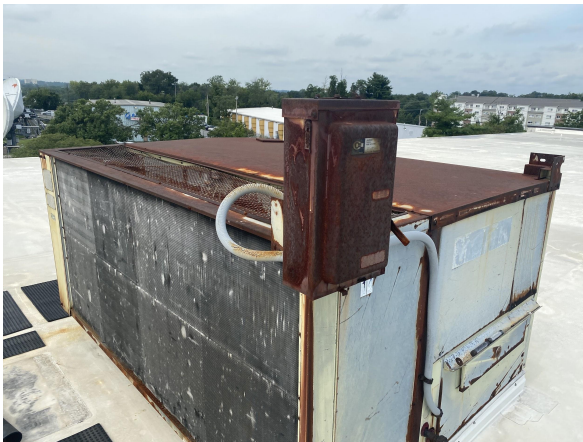
There are 13 rooftop HVAC units (RTUs). There are five compressors, two condensers, and one mini-split system located on the north side of the building. The date of manufacture on all equipment with legible data tags ranges from 1997 to 2004. All units are older; anticipate full replacement of the HVAC system in the short term.

Typical RTU

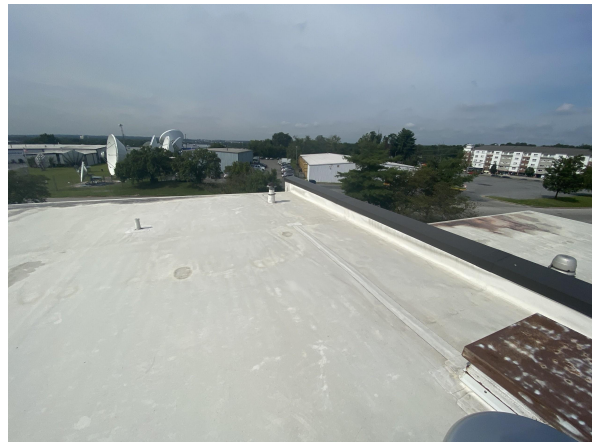
- The roof's Thermoplastic Polyolefin membrane (TPO) covering appeared to be in fair condition. Some ponding was observed and evidence of recent localized patching was noted. Replacement may be necessary in the next five years.

TPO roofing membrane

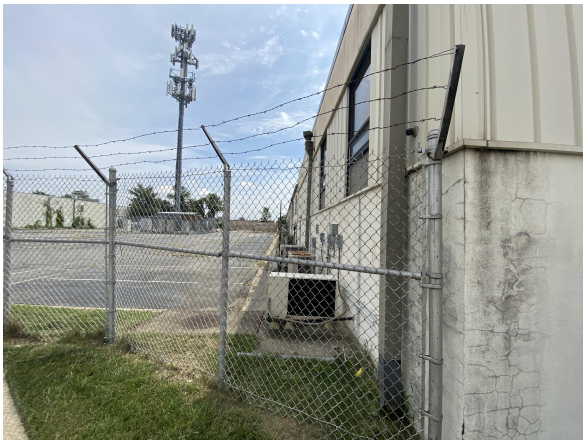
The building's envelope consists of painted stucco directly applied to CMU and standing seam metal sheathing. Light damage to the stucco was noted at the NE corner of the building; recommend repairing. Vegetation was observed growing on the building's northwest corner; recommend removing vegetation from the exterior of the building. Vegetation growth is an indicator of possible water penetration; recommend removing vegetation and evaluating the building's waterproofing system by a qualified contractor.

Damage to stucco finish at NE corner of the building
