Reserve Study for

Sample Condominium Association, Inc.

Anytown, GA

November 3, 2021

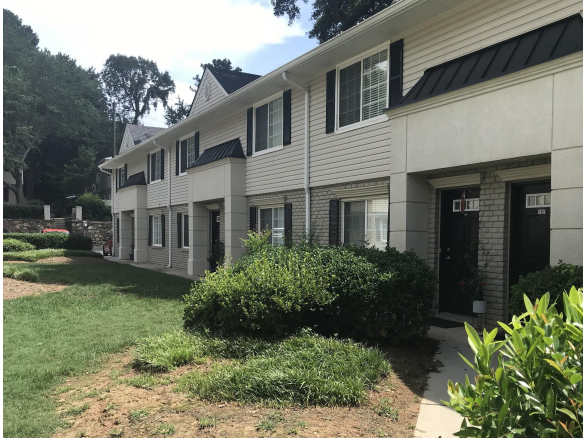
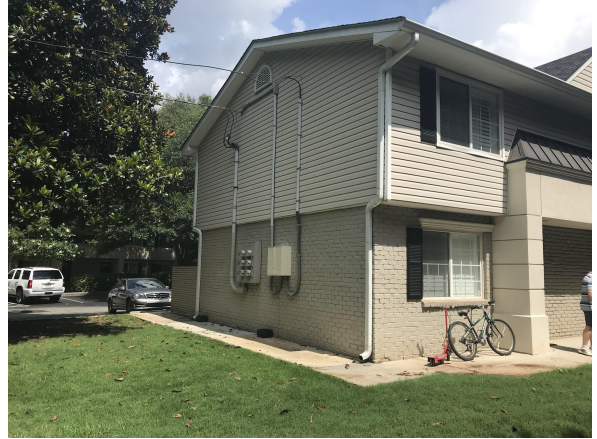
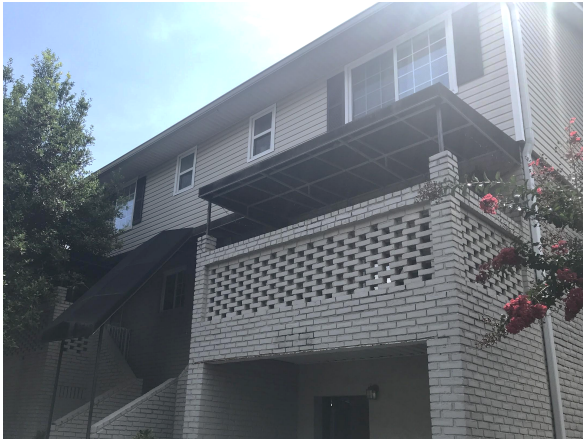
Typical building exterior surfaces

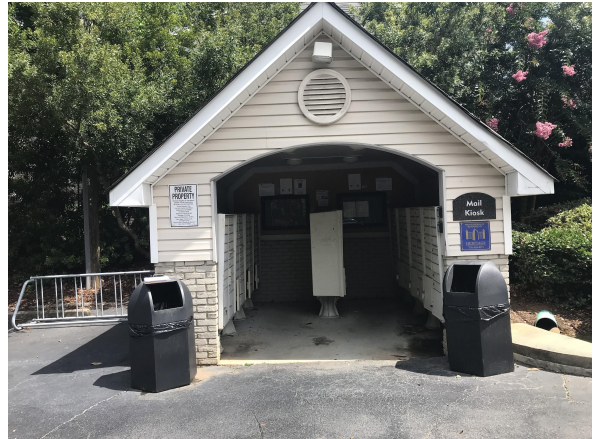
Mailbox kiosk building

Site Elements	Mailbox kiosk building repairs allowance	\$5400.00 lump sum	1 lump sum	\$5,400	3 Yrs	15 Yrs	2025 2040 2055	\$5,800 \$8,290 \$11,849	\$1,450 \$553 \$790
Site Elements	Mailbox pedestal kiosk replacement	\$2192.00 ea	10 ea	\$21,920	10 Yrs	30 Yrs	2032 2062 2092	\$27,814 \$56,824 \$116,093	\$2,529 \$1,894 \$3,870

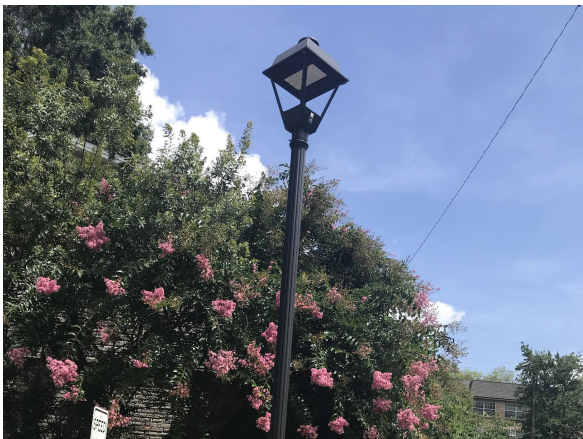
Typical light pole

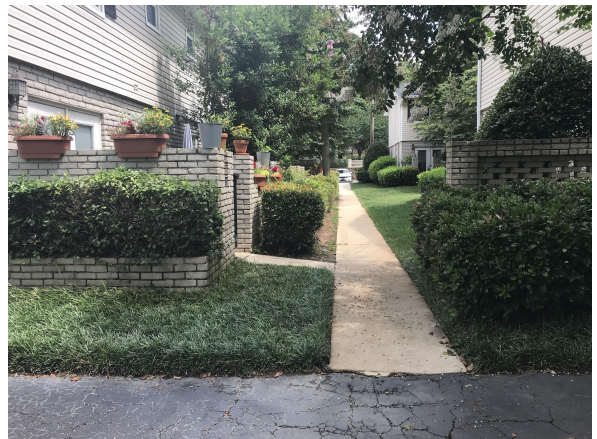
Asphalt and common are concrete

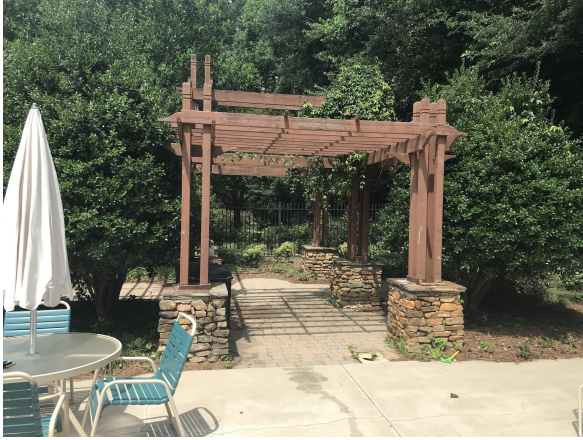
Pergola

Category	Reserve Items	Unit Cost	No Units	Current Cost When New	Estimated Remaining Life	Estimated Remaining Life When New	Year	Estimated Future Cost	Straight Line Payment
Pool Area	Pergola treated wood canopy replacement - includes masonry post bases	\$28.15 sqft	400 sqft	\$11,260	2 Yrs	30 Yrs	2024 2054 2084	\$11,809 \$24,126 \$49,291	\$3,936 \$804 \$1,643
Pool Area	Paver patio replacement - pergola area	\$11.56 sqft	400 sqft	\$4,624	20 Yrs	40 Yrs	2042 2082 2122	\$7,445 \$19,300 \$50,033	\$355 \$483 \$1,251
Site Elements	Masonry wall refurbishment allowance - 10% every 10 years - Roswell Road	\$68.50 sqft	204 sqft	\$13,974	0 Yrs	10 Yrs	2022 2032 2042	\$13,974 \$17,731 \$22,499	\$13,974 \$1,773 \$2,250
Site Elements	Brick and mortar wall replacement	\$82.20 Inft	510 Inft	\$41,922	15 Yrs	50 Yrs	2037 2087 2137	\$59,921 \$197,104 \$648,357	\$3,745 \$3,942 \$12,967
Site Elements	Replace wood retaining wall with anchor diamond wall	\$53.71 sqft	600 sqft	\$32,226	0 Yrs	35 Yrs	2022 2057 2092	\$32,226 \$74,163 \$170,676	\$32,226 \$2,119 \$4,876

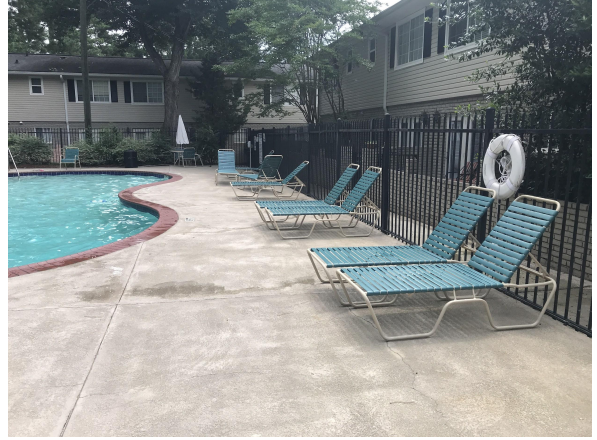
Pool area

- Per information provided by the client, the Association plans to resurface and retile the pool at the end of the 2021 swim season. A proposal in the amount of \$10,995 for the resurfacing and \$3,710 for the waterline tile replacement from Sampletown Pool Management Consultants, Inc. dated April 7, 2021, was provided to Global Solution Partners for review and inclusion in this report.

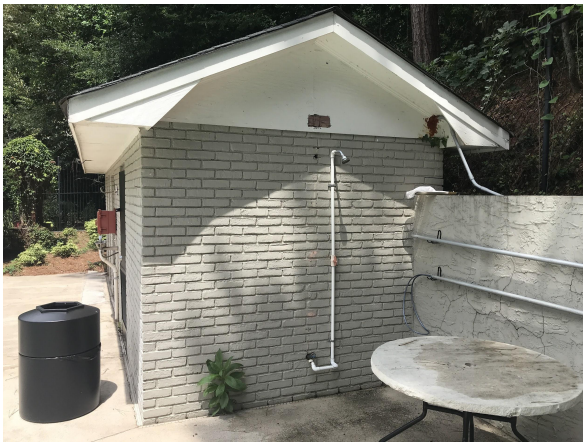
Pool house

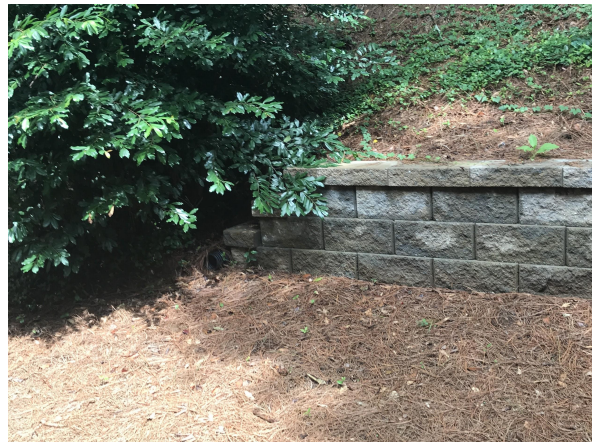
Newer retaining wall

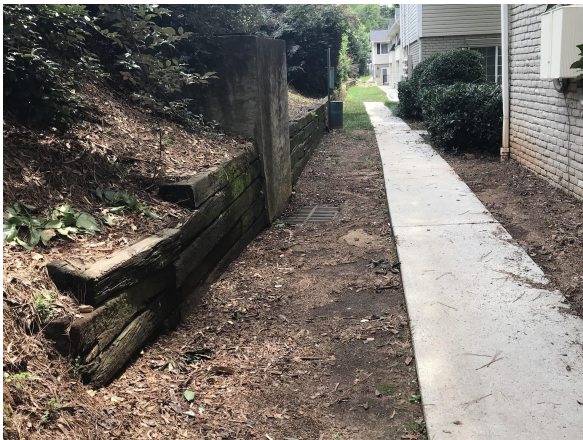
- The wood/cross tie retaining wall behind bldg. 24 is in overall poor condition. An invoice from Sampletown Landscape Management dated January 11, 2021, in the amount of \$32,324 was provided to Global Solution Partners for review and inclusion in this report. The wood wall replacement has been included in this Reserve Study as a 2022 expense.

Wood/cross tie retaining wall

Pole lighting replacement	\$4,576.00	10 Yrs	28 Yrs	2032	\$5,806.44	Y
Replace wood retaining wall with anchor diamond wall	\$32,226.00	0 Yrs	35 Yrs	2022	\$32,226.00	Y

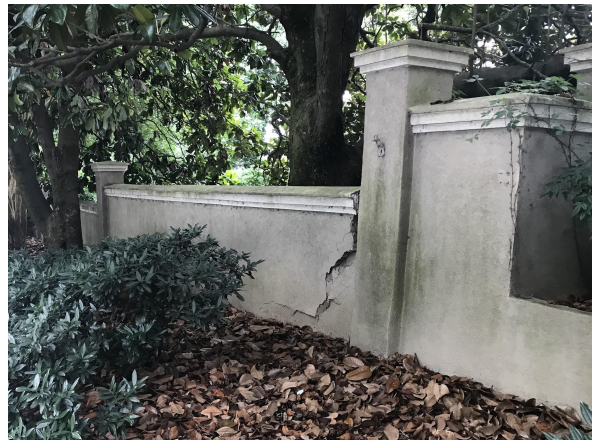
- The masonry retaining wall along Roswell Road is damaged in some sections. A repair allowance for the maintenance of the wall has been included in this Reserve Study. Recommend consultation with a qualified contractor to determine the scope of work and cost to repair, as well as to address any questions regarding its structural integrity.

Damage at front masonry wall

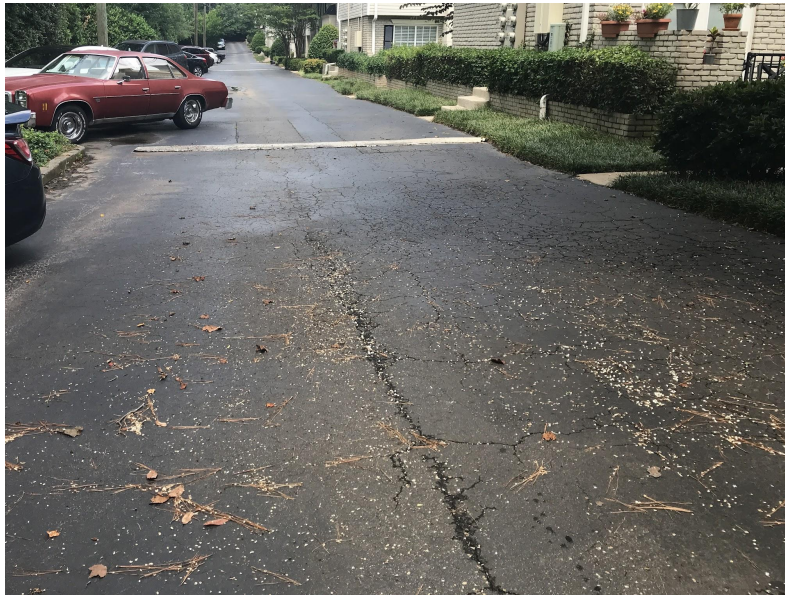
Paving

Item Name	Present Cost	Remaining Life	Expected Life	First Expense Year	First Expense	Repeating Item?
Asphalt paved parking areas mill and overlay	\$188,294.00	5 Yrs	30 Yrs	2027	\$212,103.73	Y
Asphalt paved parking areas seal and restripe	\$15,063.52	1 Yrs	5 Yrs	2023	\$15,426.55	Y
Concrete curb repair allowance (10% every 10 years)	\$6,270.60	6 Yrs	10 Yrs	2028	\$7,233.75	Y
Concrete dumpster pad replacement	\$1,998.00	10 Yrs	20 Yrs	2032	\$2,535.24	Y
Concrete walkways repair allowance (10% every 10 years)	\$4,262.40	10 Yrs	10 Yrs	2032	\$5,408.51	Y
Stamped concrete roads replacement - at entrance	\$27,184.00	6 Yrs	30 Yrs	2028	\$31,359.39	Y

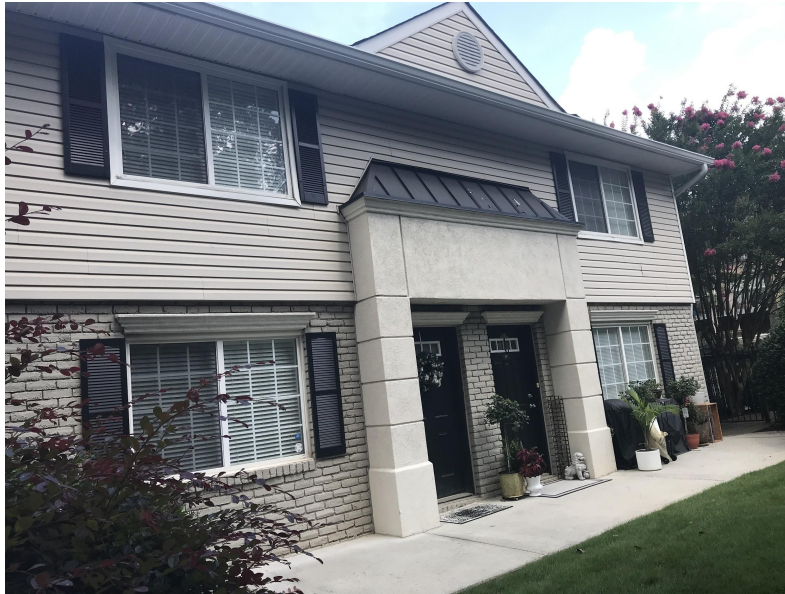
Building Exteriors

Item Name	Present Cost	Remaining Life	Expected Life	First Expense Year	First Expense	Repeating Item?
Aluminum rain gutters replacement - 10% every 5 years	\$6,313.78	5 Yrs	5 Yrs	2027	\$7,112.16	Y
Asphalt shingle roofing replacement - TBD - 2021	\$65,700.00	19 Yrs	20 Yrs	2041	\$103,292.87	Y
Asphalt shingle roofing replacement - TBD - 2022	\$82,125.00	0 Yrs	20 Yrs	2022	\$82,125.00	Y
Asphalt shingle roofing replacement - TBD - 2023	\$65,700.00	1 Yrs	20 Yrs	2023	\$67,283.37	Y
Asphalt shingle roofing replacement - TBD - 2024	\$32,850.00	2 Yrs	20 Yrs	2024	\$34,452.45	Y
Asphalt shingle roofing replacement -2019	\$82,125.00	17 Yrs	20 Yrs	2039	\$123,110.65	Y
Asphalt shingle roofing replacement -2020	\$82,125.00	18 Yrs	20 Yrs	2040	\$126,077.61	Y
Awnings fabric & frame replacement allowance	\$5,000.00	3 Yrs	5 Yrs	2025	\$5,370.28	Y
Decorative shutter replacement	\$14,385.00	12 Yrs	30 Yrs	2034	\$19,143.36	Y
Exterior painting - stucco and brick	\$83,520.00	2 Yrs	10 Yrs	2024	\$87,594.17	Y

Vinyl exterior siding surfaces replacement	\$662,220.00	12 Yrs	30 Yrs	2034	\$881,273.45	Y

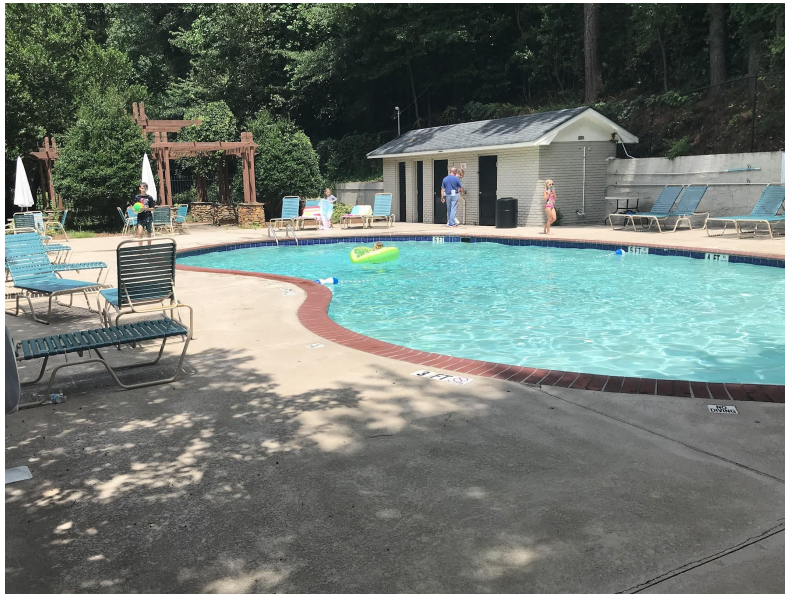
Pool Area

Item Name	Present Cost	Remaining Life	Expected Life	First Expense Year	First Expense	Repeating Item?
Aluminum pool fencing replacement	\$11,097.00	13 Yrs	25 Yrs	2035	\$15,123.64	Y
Asphalt shingle roofing replacement for pool house	\$1,503.36	2 Yrs	20 Yrs	2024	\$1,576.70	Y
Concrete pool deck resurface	\$36,565.30	5 Yrs	25 Yrs	2027	\$41,188.97	Y
Exterior doors replacement for pool house	\$3,836.00	1 Yrs	30 Yrs	2023	\$3,928.45	Y
Paver patio replacement - pergola area	\$4,624.00	20 Yrs	40 Yrs	2042	\$7,445.01	Y
Pergola treated wood canopy replacement - includes masonry post bases	\$11,260.00	2 Yrs	30 Yrs	2024	\$11,809.27	Y
Pool coping replacement	\$27,022.39	5 Yrs	25 Yrs	2027	\$30,439.37	Y
Pool equipment pumps and filters system replacement	\$7,398.00	5 Yrs	10 Yrs	2027	\$8,333.48	Y
Pool furniture replacement	\$7,500.00	3 Yrs	5 Yrs	2025	\$8,055.42	Y
Pool house bathrooms refurbish	\$9,700.00	1 Yrs	16 Yrs	2023	\$9,933.77	Y

Pool resurface	\$10,986.71	12 Yrs	12 Yrs	2034	\$14,620.97	Y
Pool tile and coping replacement	\$9,247.50	5 Yrs	12 Yrs	2027	\$10,416.84	Y
Pool waterline tile replacement	\$3,710.70	12 Yrs	12 Yrs	2034	\$4,938.15	Y

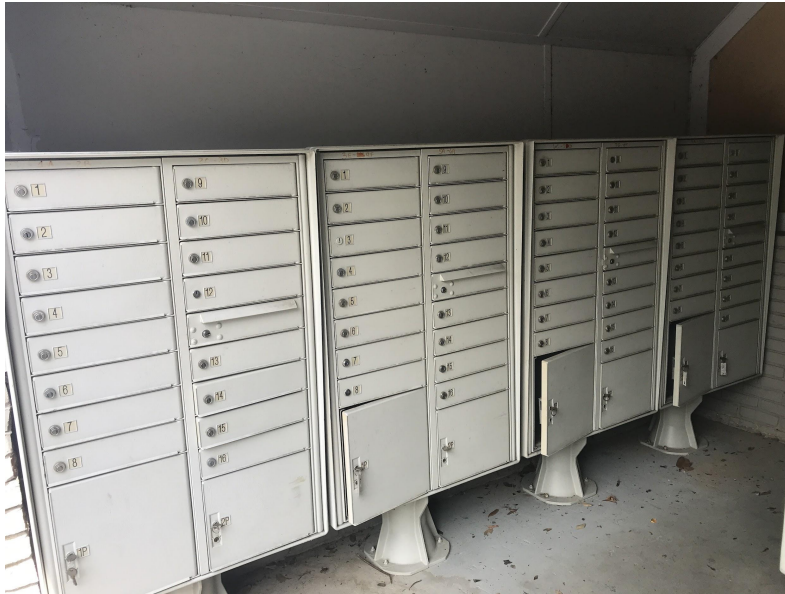
Site Elements

Item Name	Present Cost	Remaining Life	Expected Life	First Expense Year	First Expense	Repeating Item?
Arm gate operator replacement	\$4,521.00	7 Yrs	10 Yrs	2029	\$5,341.10	Y
Automatic gate opener control panel replacement	\$4,156.00	5 Yrs	12 Yrs	2027	\$4,681.53	Y
Automatic gate opener replacement	\$16,440.00	5 Yrs	10 Yrs	2027	\$18,518.83	Y
Brick and mortar wall replacement	\$41,922.00	15 Yrs	50 Yrs	2037	\$59,920.78	Y
Chain-link fencing replacement - dog park	\$7,288.40	18 Yrs	24 Yrs	2040	\$11,189.09	Y
Entrance and monuments refurbishment	\$13,700.00	25 Yrs	30 Yrs	2047	\$24,847.33	Y
Entry gates refurbish	\$4,932.00	0 Yrs	15 Yrs	2022	\$4,932.00	Y
Irrigation system equipment replacement allowance	\$4,110.00	3 Yrs	7 Yrs	2025	\$4,414.37	Y
Mailbox kiosk building repairs allowance	\$5,400.00	3 Yrs	15 Yrs	2025	\$5,799.90	Y
Mailbox pedestal kiosk replacement	\$21,920.00	10 Yrs	30 Yrs	2032	\$27,814.05	Y
Masonry wall refurbishment allowance - 10% every 10 years - Roswell Road	\$13,974.00	0 Yrs	10 Yrs	2022	\$13,974.00	Y

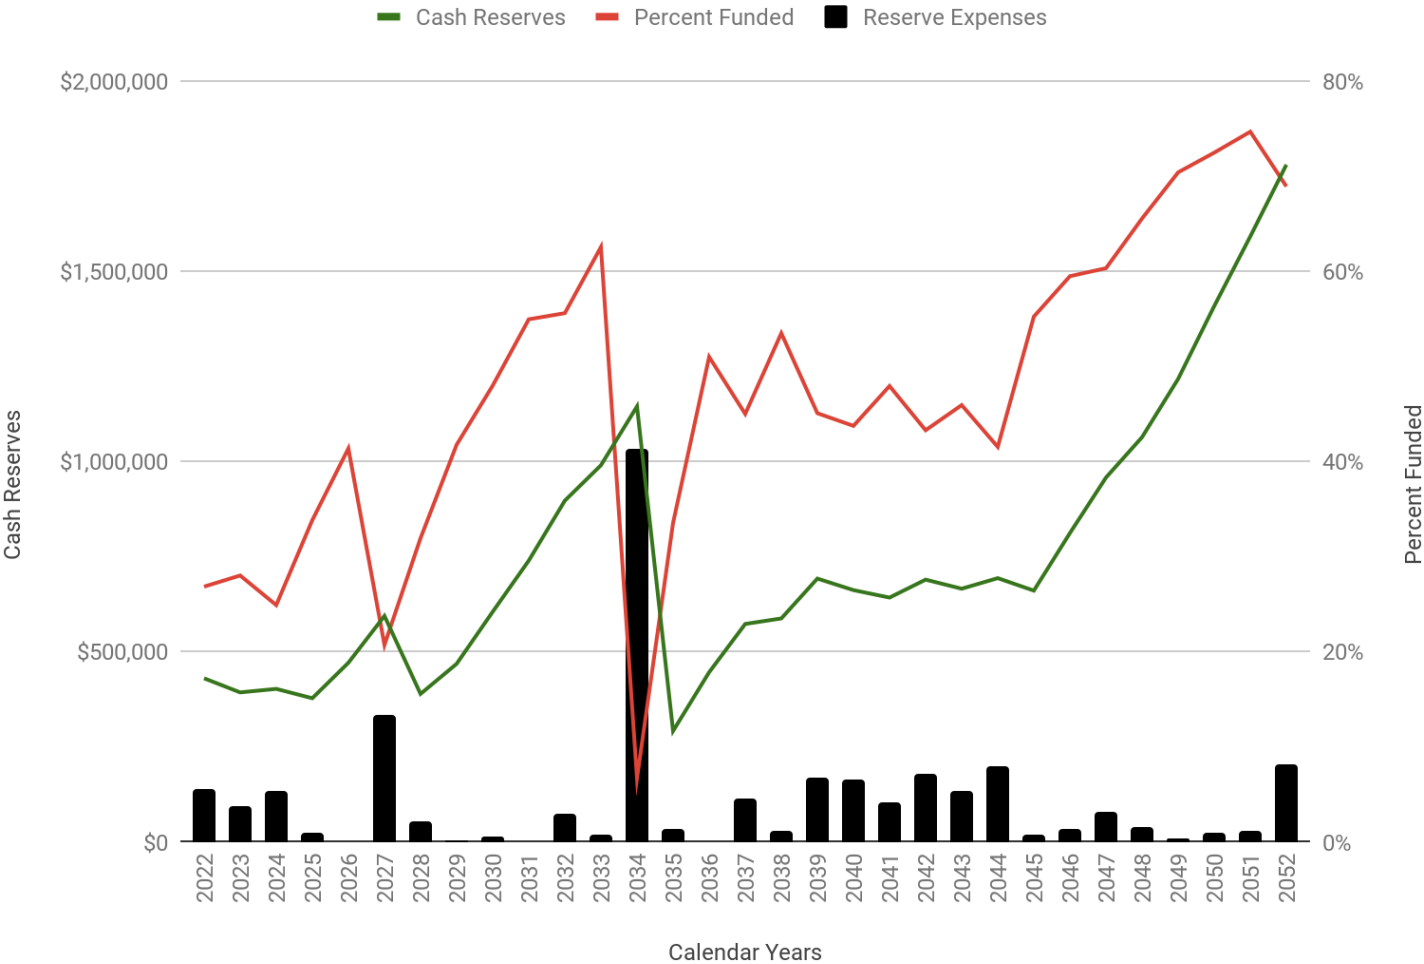
Cash Flow by Calendar Year

The following chart shows that the reserve account balance meets or exceeds the annual cash flow requirement for the maintenance or replacement of all community reserve items.
