**Reserve Study for**

**Sample Homeowners Association, Inc.**

**Sampletown, FL**

**October 12, 2025**

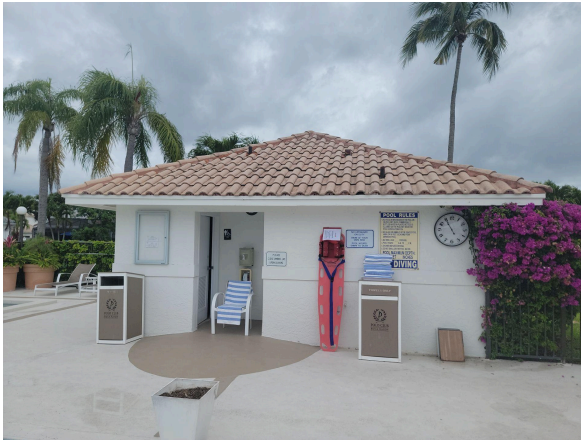
Pool house

- The pool house tile roof has an expected life of 50 years when new. Due to typical underlayment failure at approximately 30 years, Global Solution Partners has factored roofing replacement into the reserves at 30 years of age. Various conditions may impact the actual life expectancy; therefore, it is recommended that periodic evaluations be performed by a qualified contractor and that the Reserve Study be updated accordingly.

- The evaluation of the pool house roofing system is limited to determining the approximate remaining useful life to allow for sufficient funds to be available for future replacement. The evaluation is visual in nature and does not include any detailed inspection or engineering analysis. Global Solution Partners recommends that a qualified roofing contractor be retained to obtain a detailed inspection. Results of any third-party evaluation may be incorporated into a future update of this report.

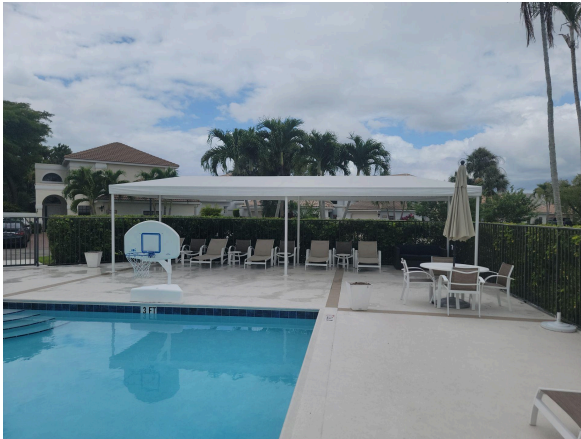
Pool area

- Per information provided by the client, the replacement of the pool house roof, pool perimeter fencing, and pool resurfacing will be completed this year. Global Solution Partners has included this information in the Reserve Study.

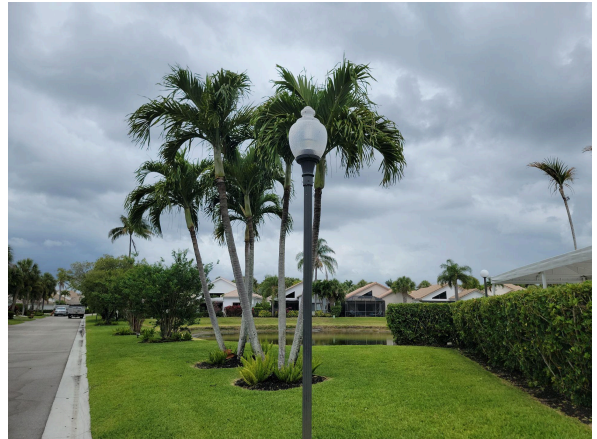
Typical street light

| Item Name | Present Cost | Remaining Life | Expected Life | First Expense Year | First Expense | Repeating Item? |
|---|---|---|---|---|---|---|
| Street lighting replacement | \$82,844.30 | 14 Yrs | 28 Yrs | 2040 | \$118,180.99 | Y |

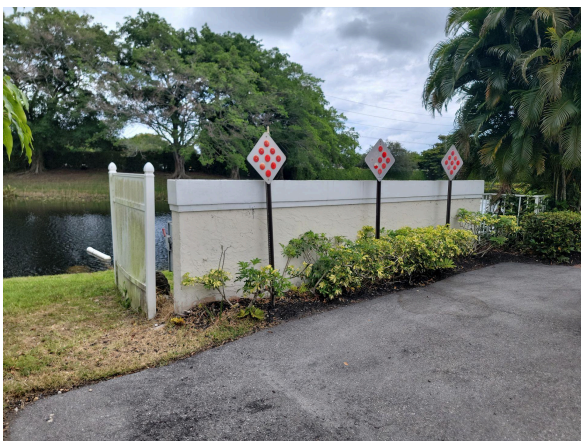
Stucco wall at end of the street

| Item Name | Present Cost | Remaining Life | Expected Life | First Expense Year | First Expense | Repeating Item? |
|---|---|---|---|---|---|---|
| Block and stucco wall painting and general repairs - walls throughout community | \$10,632.96 | 3 Yrs | 8 Yrs | 2029 | \$11,474.01 | Y |

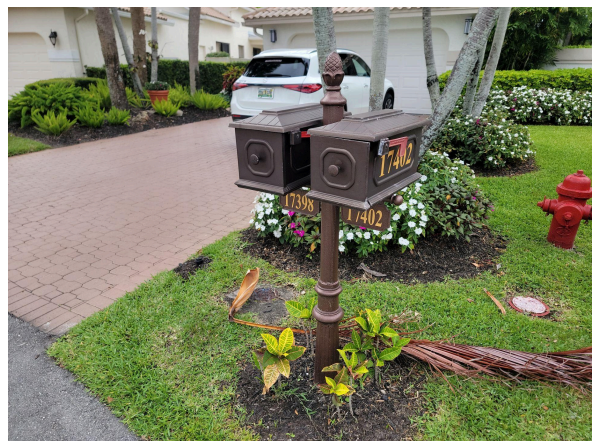
Mailboxes

| Item Name | Present Cost | Remaining Life | Expected Life | First Expense Year | First Expense | Repeating Item? |
|---|---|---|---|---|---|---|
| Mailboxes and posts replacement | \$45,290.70 | 6 Yrs | 20 Yrs | 2032 | \$52,738.91 | Y |

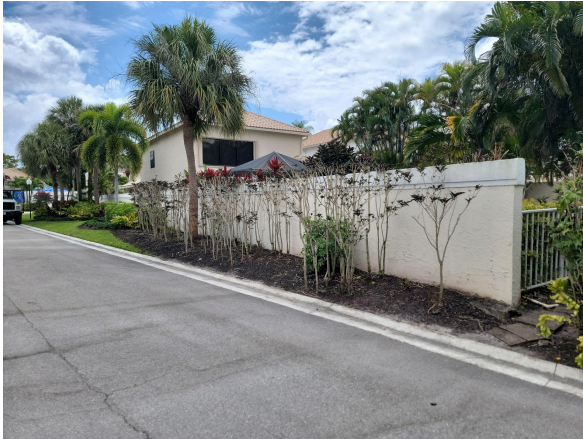
Stucco walls throughout community

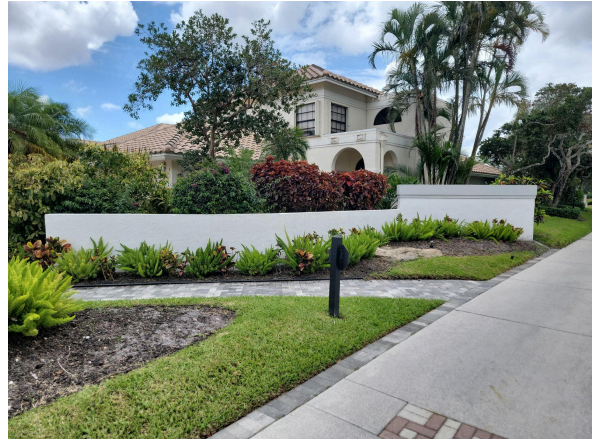
Stucco wall at entrance of community

| Item Name | Present Cost | Remaining Life | Expected Life | First Expense Year | First Expense | Repeating Item? |
|---|---|---|---|---|---|---|
| Block and stucco wall painting and general repairs - at entrance | \$1,092.00 | 3 Yrs | 8 Yrs | 2029 | \$1,178.38 | Y |

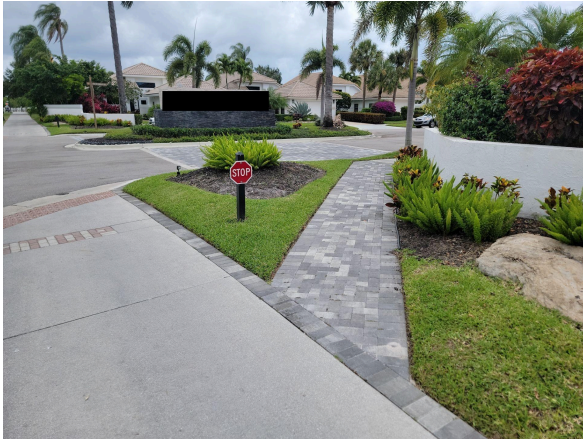
Entrance to community

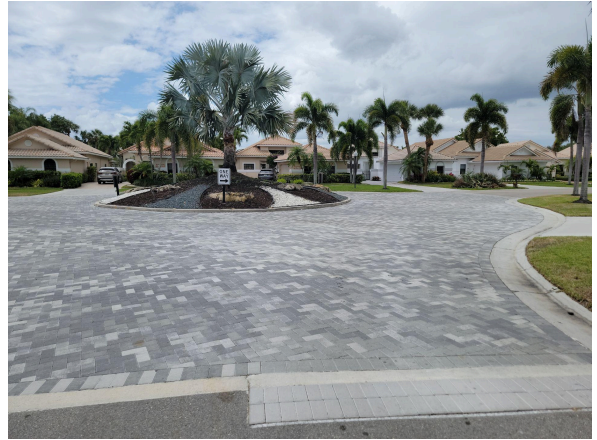
Paver traffic circle

| Item Name | Present Cost | Remaining Life | Expected Life | First Expense Year | First Expense | Repeating Item? |
|---|---|---|---|---|---|---|
| Pavers streets and walkways replacement allowance (10% every 5 years) | \$14,634.75 | 3 Yrs | 5 Yrs | 2029 | \$15,792.34 | Y |

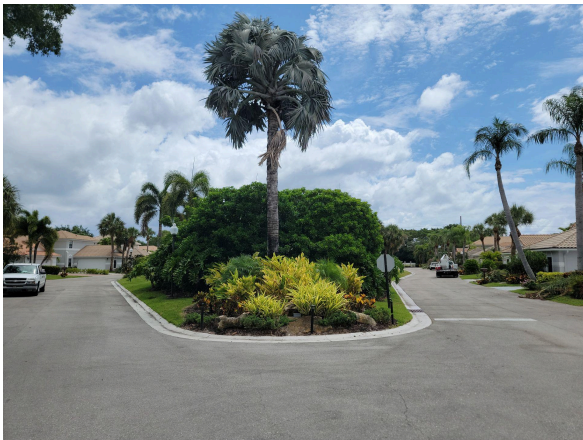
- The asphalt surfaces were observed to be in good condition. Asphalt surfaces should be resealed on a five-year schedule to provide protection from oxidation due to exposure to the sun and elements, minimize surface cracking, and enhance the aesthetics of the community.

Asphalt street and landscaping

| Item Name | Present Cost | Remaining Life | Expected Life | First Expense Year | First Expense | Repeating Item? |
|---|---|---|---|---|---|---|
| Asphalt streets and parking area mill and overlay | \$175,292.60 | 23 Yrs | 25 Yrs | 2049 | \$314,218.51 | Y |

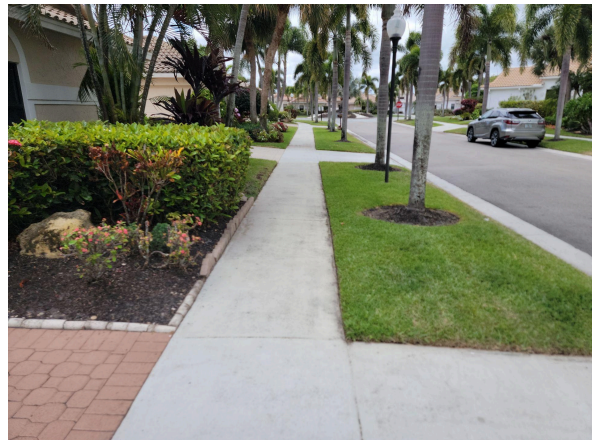
Typical sidewalk in community

| Item Name | Present Cost | Remaining Life | Expected Life | First Expense Year | First Expense | Repeating Item? |
|---|---|---|---|---|---|---|
| Concrete sidewalks repair allowance (10% every 10 years) | \$8,030.68 | 8 Yrs | 10 Yrs | 2034 | \$9,838.19 | Y |
